# Ground Penetrating Radar: An Effective Tool for Locating Dry Caves Along a Portion of State Route 69 Near Mayer, Yavapai County, Arizona.\*

Kenneth M. Euge, R.G. (Principal Geologist, Geological Consultants Inc., Phoenix, AZ)  
Kerry Hennon, R.Gp. (Project Geophysicist, Geological Consultants Inc., Phoenix, AZ)  
Jason C. Williams, G.I.T. (Staff Geologist, Geological Consultants Inc., Phoenix, AZ)  
Nick M. Priznar, (Geologist, Arizona Department of Transportation, Phoenix, AZ)

\* Technical paper initially presented to the 49<sup>th</sup> Highway Geology Symposium, September 10, 1998.

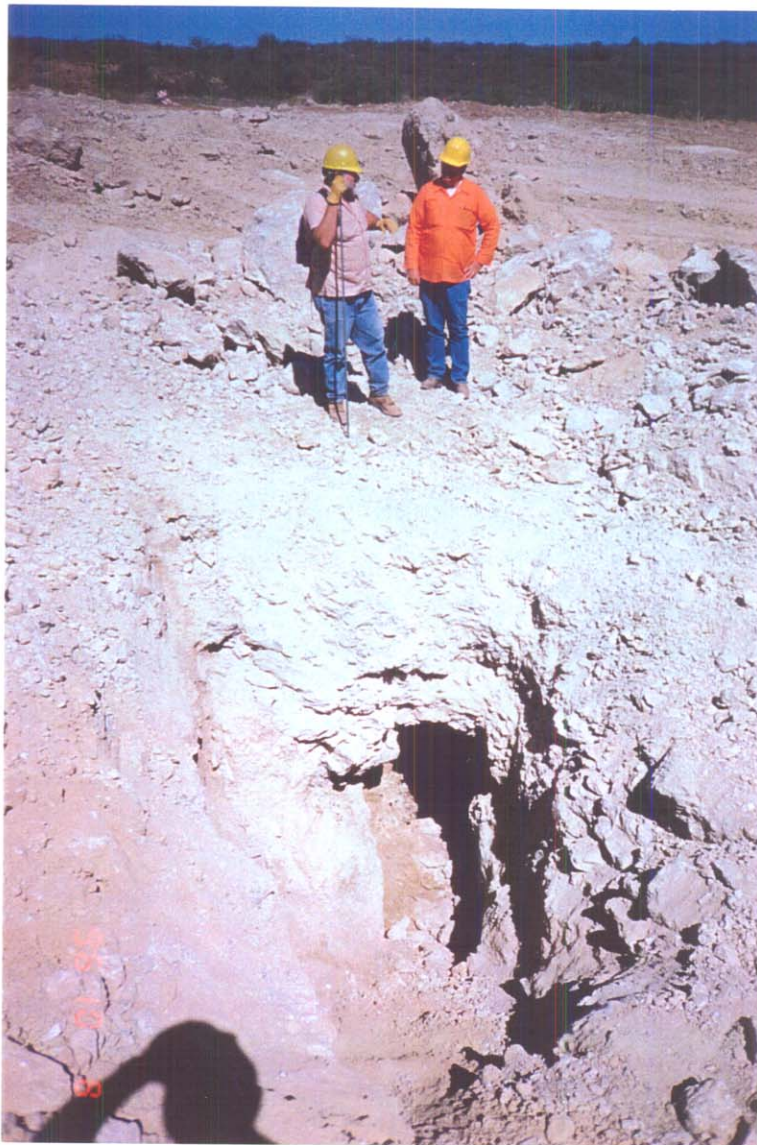
**Figure 2** Cave area collapsed by D-9 dozer.

During excavation of the south bound lanes and shoulder in 1996, a D-9 Caterpillar tractor was using its single-shank ripper to breakout strongly cemented breccia and travertine limestone bedrock that had been previously fragmented by blasting. Without warning, the D-9 broke through the ground surface and dropped about 6 feet into an open void (Figure 2).

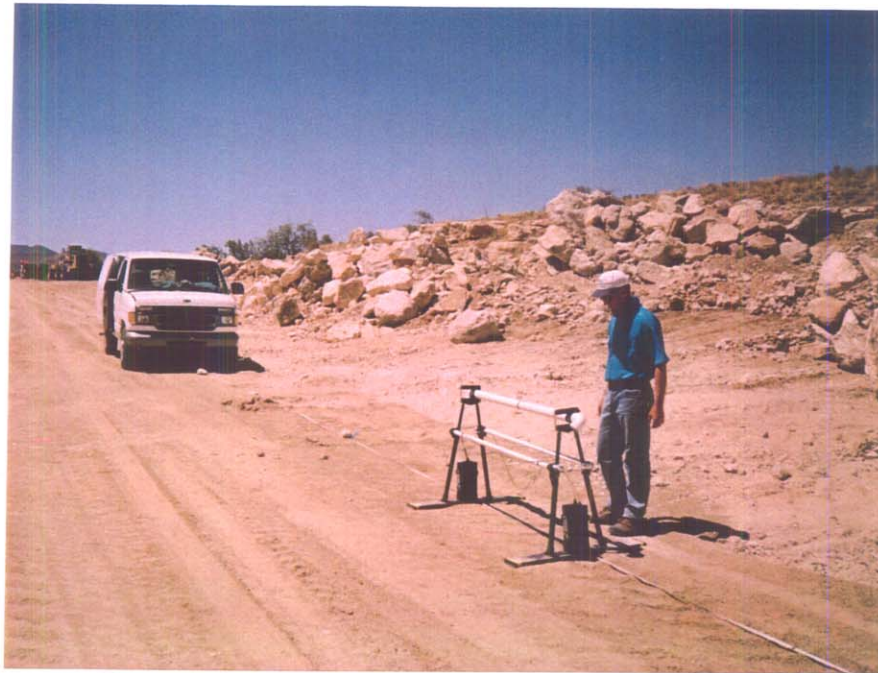
**Figure 4** GPR antenna/receiver collecting data along profile line

The radar survey was designed to detect voids within the upper 30 feet that could collapse and expose the traveling public to potential hazards along the roadway. The smallest void of interest was estimated to be a cube two feet on each side. Collapse of smaller dimension voids would probably not seriously effect the roadway. The GPR measurement parameters were chosen to detect voids with a vertical dimension larger than two feet (Figure 4).

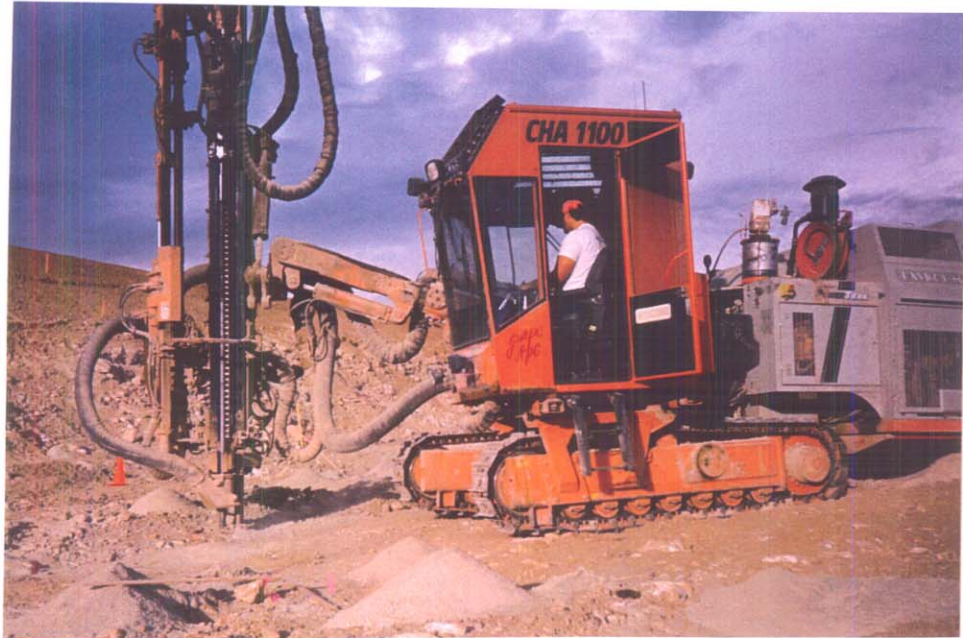
**Figure 8** Air track drill used for anomaly verification along south bound lanes segment.

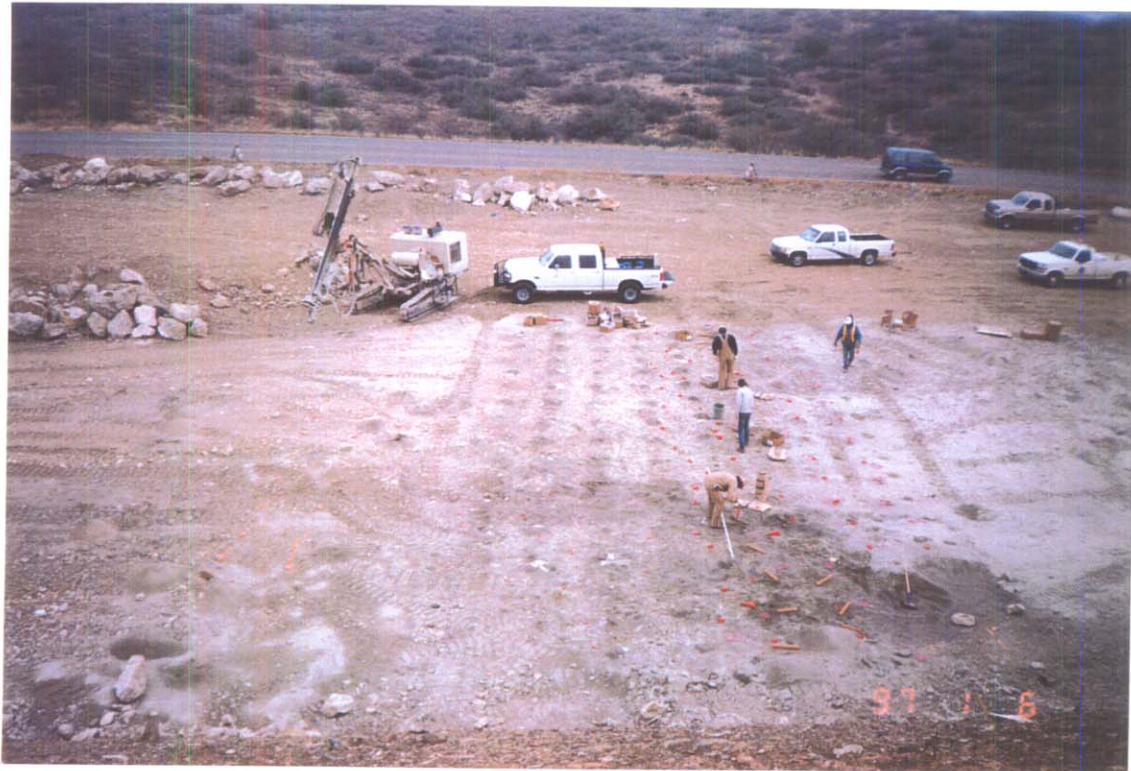
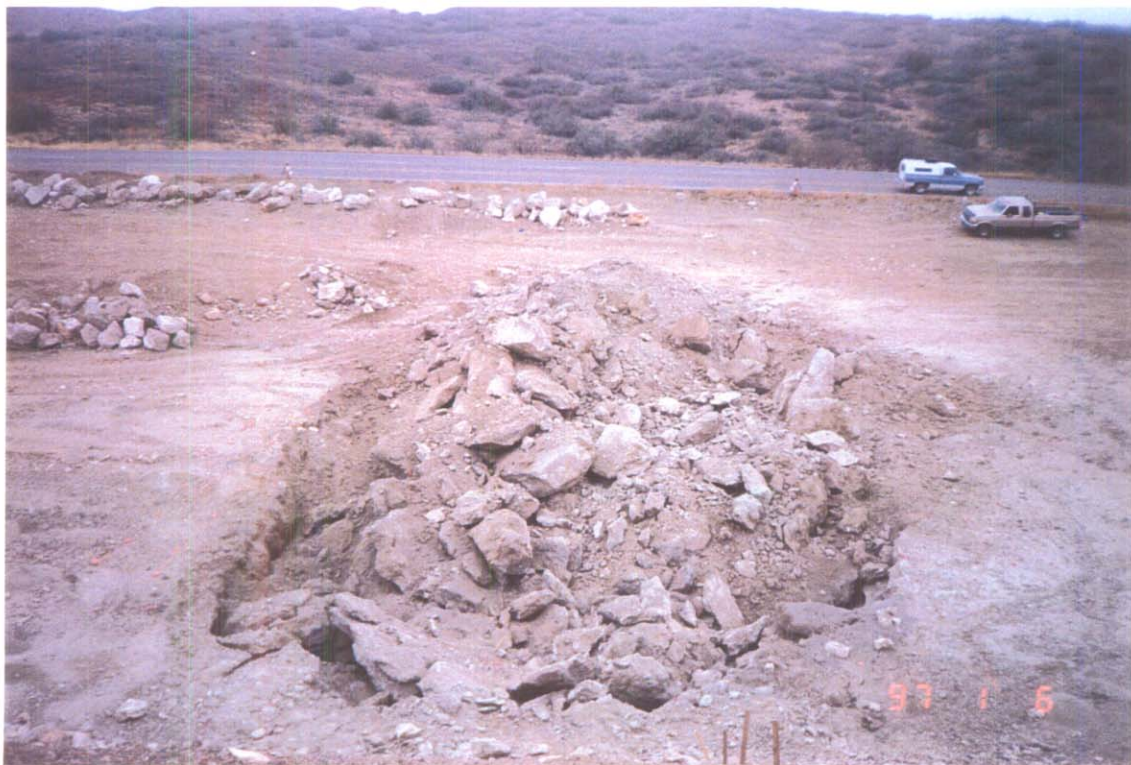
**Figure 10.1** (Top ) Shot hole pattern for shot designed to collapse roof of near-surface cave structure; (Bottom) Cave roof collapsed by blasting.

This phase of work included the drilling out (defining) of void areas which were initially characterized during the anomaly verification test drilling program (Figure 10). Once a void area was defined, it was then selected for either blasting or grouting at the direction of ADOT. Three void areas were shot during this period of work to remove the void roof. Areas opened by blasting were further mitigated by removing all of the blast debris and backfilling the open void with a controlled fill. A geogrid type filter fabric was installed prior to backfilling to prevent piping of fine grain sediments into deeper voids. As directed by ADOT, some of the smaller void areas were not shot. Void areas not shot were filled to the fullest possible level using a sand-cement grout.

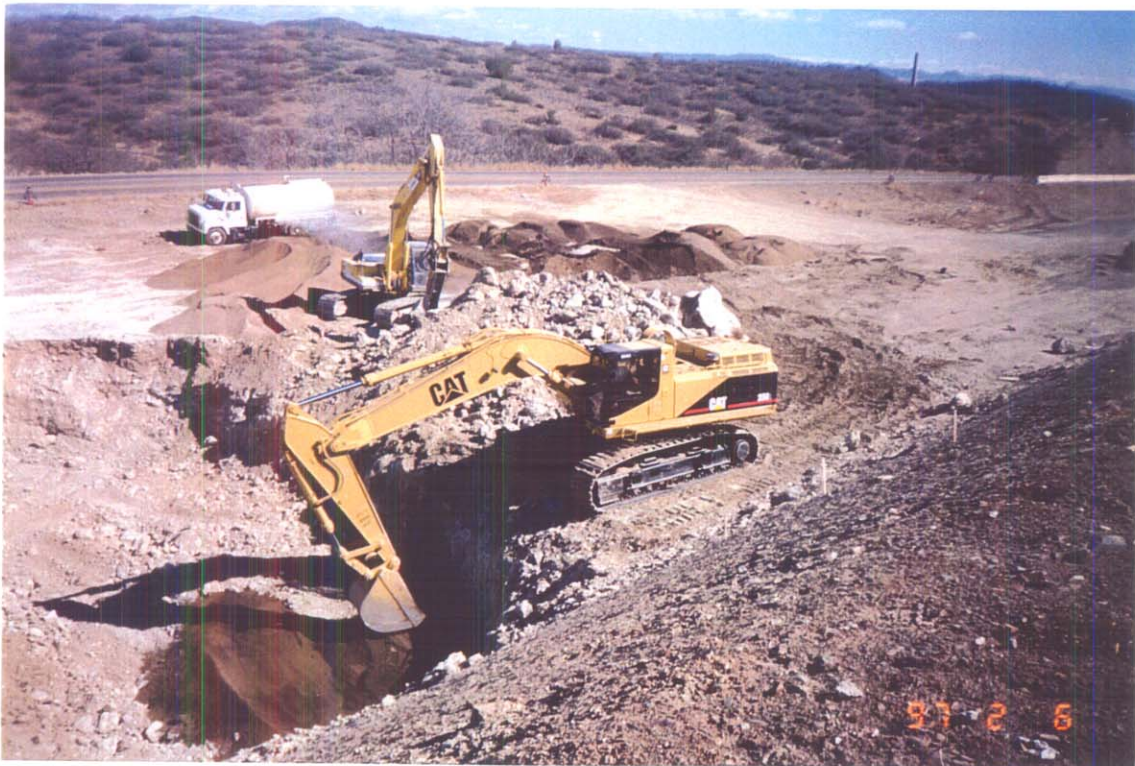
**Figure 10.2** (c) Final remediation of collapsed cave structure with select backfill.

Numerous irregularly-shaped voids of small ( $\pm 2$  feet in diameter) to large (greater than 20 feet in diameter) were interpreted in a zone that extends from 3 to 40 feet below roadway grades. Remediation efforts were concentrated within the upper 20 feet of the section in an effort to form a reasonably stable platform to "bridge" the known lower voids. Remediation in the upper 20 feet of the roadway section included the opening of large near surface voids by blasting followed by their subsequent backfill with an engineered fill. Smaller void areas were filled with a standard grout mix.
